## This Week's Water Conditions Update

September 3, 2021

### Featured Water Quality Monitoring Tool: RECON

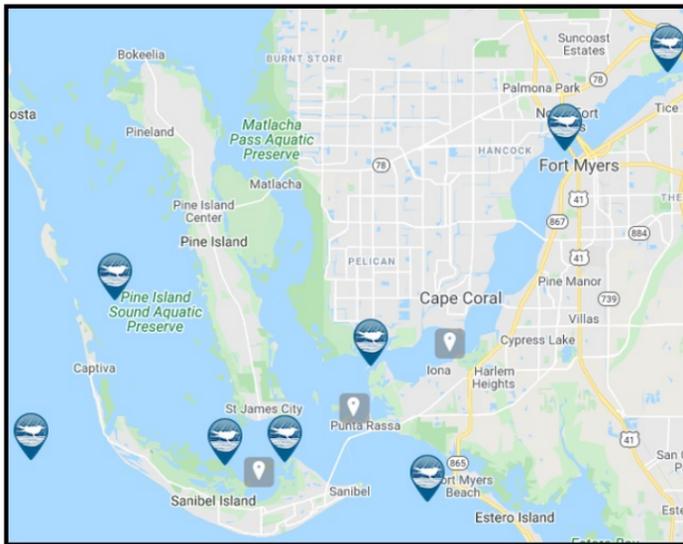
Continuous, in situ (on site), water quality data throughout the Caloosahatchee Estuary helps SCCF scientists, policy makers, and the general public monitor conditions using real time data. Our [River, Estuary, and Coastal Observing Network \(RECON\)](#) consists of eight water quality sensors that have been deployed since 2007 providing a comprehensive, long term data set of water quality parameters such as salinity, temperature, chlorophyll, oxygen, turbidity, and more. These data help us determine where nutrient and algal bloom hotspots occur and can be used to evaluate

habitat quality for important species such as seagrass and oysters. SCCF recently received funding from Lee County, the City of Sanibel, and a few concerned and longstanding donors to fully replace and upgrade the RECON sensor network for the first time in 14 years. This generous support will help SCCF continue our scientific evaluation of water quality, advocate for policies that improve water quality, and educate the public on water conditions.

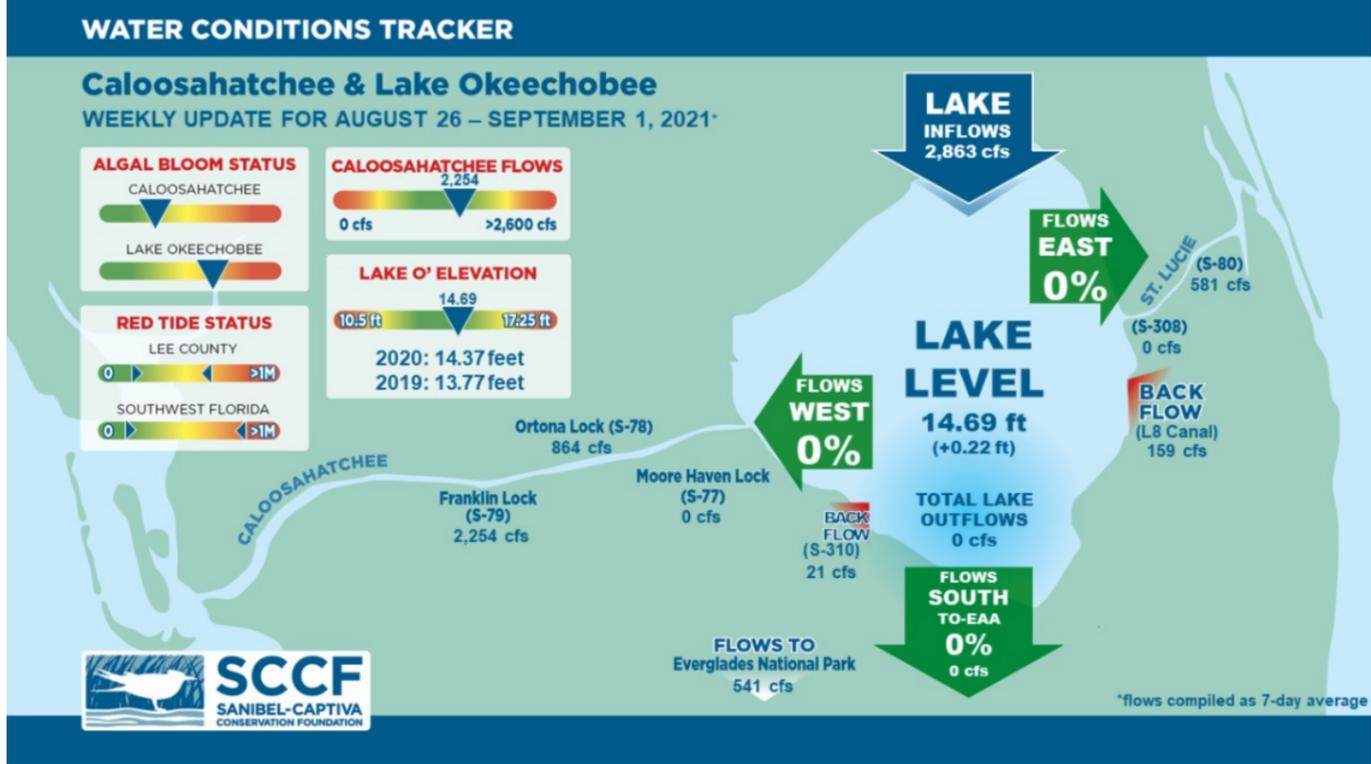
On September 1, 2021 Lake Okeechobee was at 14.69 feet (+0.22 feet). The lake stage increased from enhanced rainfall throughout the region and has been above the preferred ecological envelope since early July. The preferred ecological envelope for Lake Okeechobee is based on conditions that facilitate healthy littoral (nearshore) and wetland ecosystems around the lake. To learn more about Lake Okeechobee's complex and important ecosystem functions and the preferred ecological envelope, you can read the scientific and technical document called the [Lake Okeechobee Performance Measure for Lake Stage](#) that is part of [RECOVER \(REstoration COordination & VERification\)](#).

The volume of water reaching the Caloosahatchee from the watershed has increased to an average of 2,254 cfs this week. However, the 14-day average flow on 9/1/21 was 1,919 cfs which is in the optimum flow envelope for the Caloosahatchee estuary. We have been in the optimum flow envelope for 6 days after 7 weeks of being above the optimal flow envelope. This volume is measured at the Franklin Lock and Dam (S-79) in Alva.

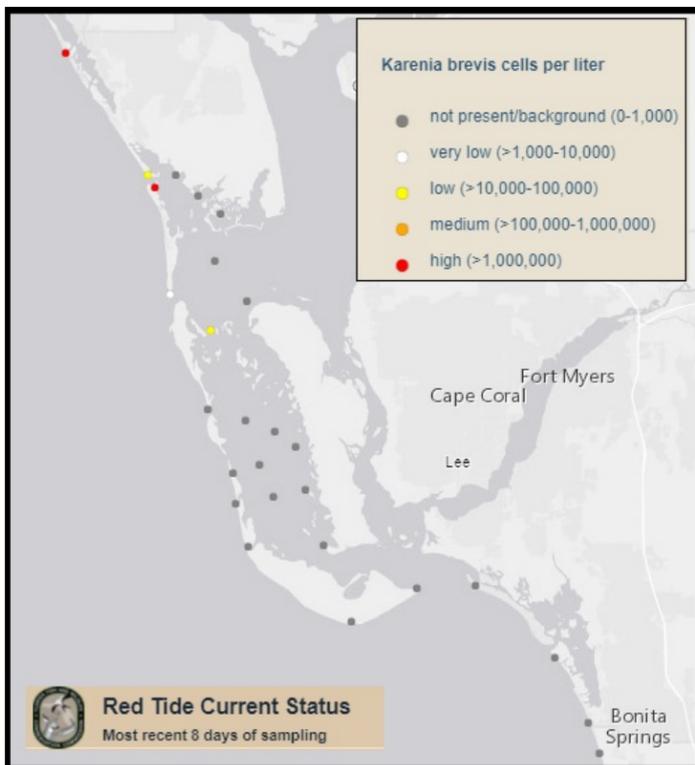
Currently, red tide has a patchy and rapidly changing distribution in Southwest Florida. [Satellite imagery](#) over the past week has shown high levels of chlorophyll off of the coast of Sarasota and Lee Counties. This imagery corresponds to water samples with bloom concentrations of *Karenia brevis*, and other algal species may be contributing to the high chlorophyll levels as well. In Lee County, FWC reported very low to low levels of *Karenia brevis* in Gasparilla Sound, not present to low concentrations in Pine Island Sound and not present concentrations on the Gulf side of Sanibel and Fort Myers Beach. CROW, the wildlife hospital on Sanibel received 12 patients with toxicosis symptoms (from red tide or blue-green algae) from 8/22/21 - 8/30/21.
