This Week's Water Conditions Update

September 10, 2021

Lake Okeechobee Levels & Caloosahatchee Flow Impacts

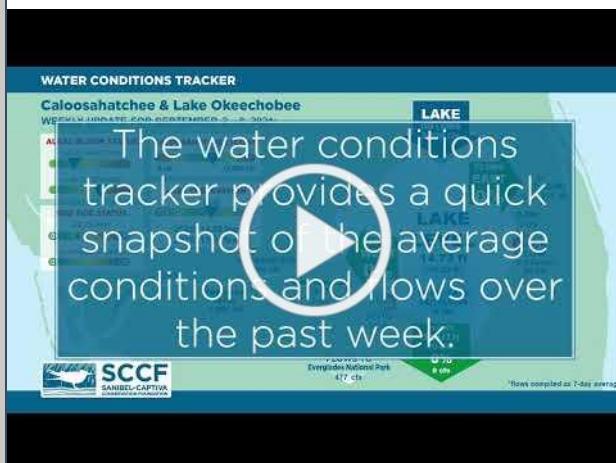
Our water conditions tracker is intended to give you a quick and simple snapshot of a complex and dynamic system. Our [video tutorial](#) explains what each section of the graphic means so that you can know the status of blue-green algae, red tide, lake levels, and flow throughout the system at a glance.

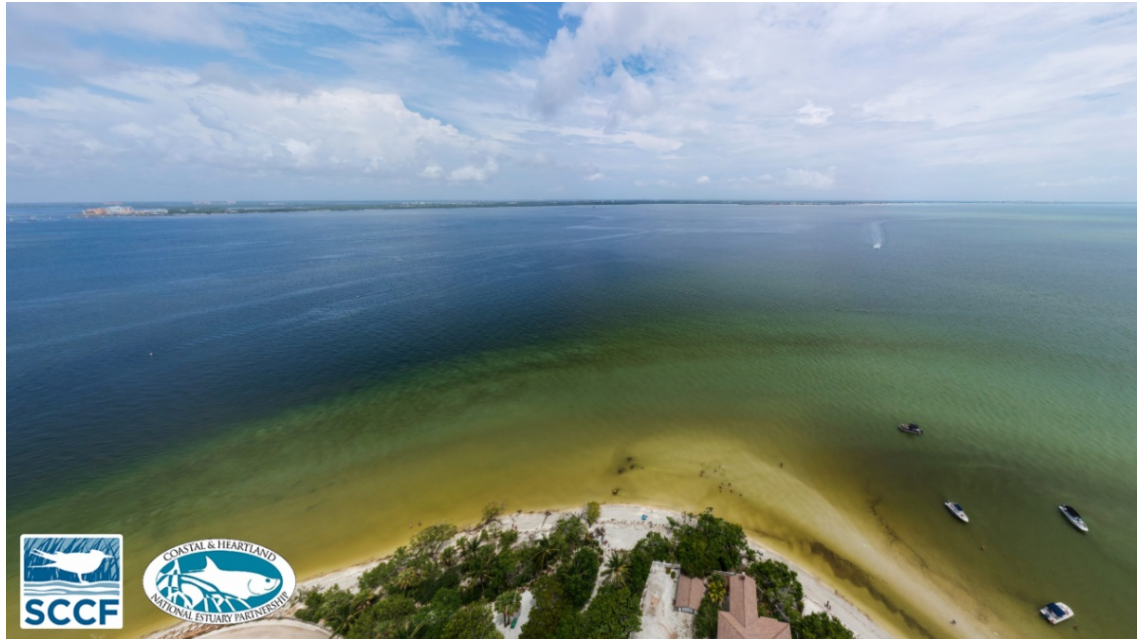
Virtual Water Quality Tour from Lighthouse Beach

[Click here](#) or on the image above to take a virtual tour from above Lighthouse Beach Park to see how the water looked this week.

With no flows from Lake Okeechobee, water clarity and quality is only being affected by the watershed and stormwater runoff from rain.
