## This Week's Water Conditions Update

September 17, 2021

### Lake Okeechobee Levels & Caloosahatchee Flow Impacts

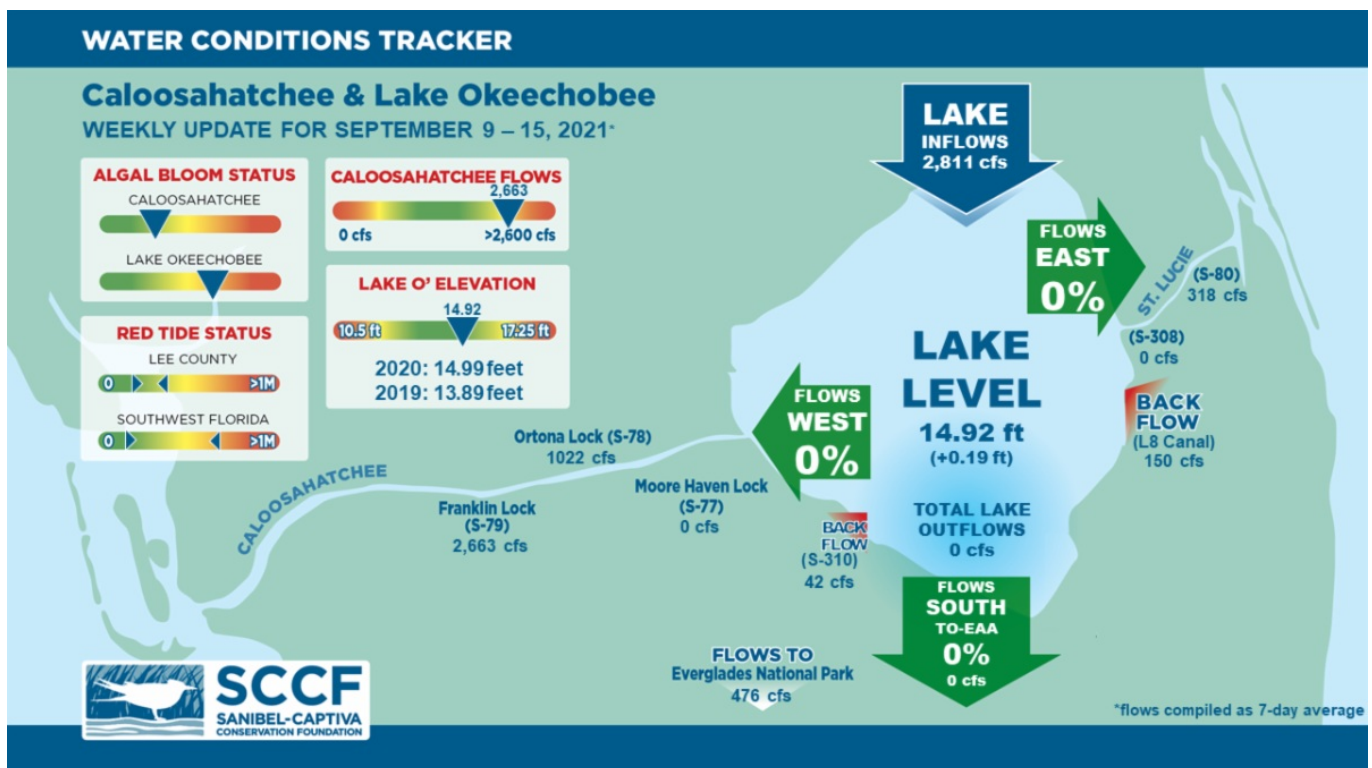
### Water Conditions Tracker

On September 15, 2021 Lake Okeechobee was at 14.92 feet (+0.19 feet in the past week). The average volume of water reaching the Caloosahatchee from the watershed was 2,663 cfs (cubic feet per second) this week. The 14-day average flow on 9/15/21 was 2,262 cfs which is in the **stress flow envelope** for the Caloosahatchee estuary. This volume is measured at the Franklin Lock and Dam (S-79) in Alva. As of 9/15/21 flows from S-79 have been in the stress flow envelope for 7 days. We are still not receiving any

flows from Lake Okeechobee.

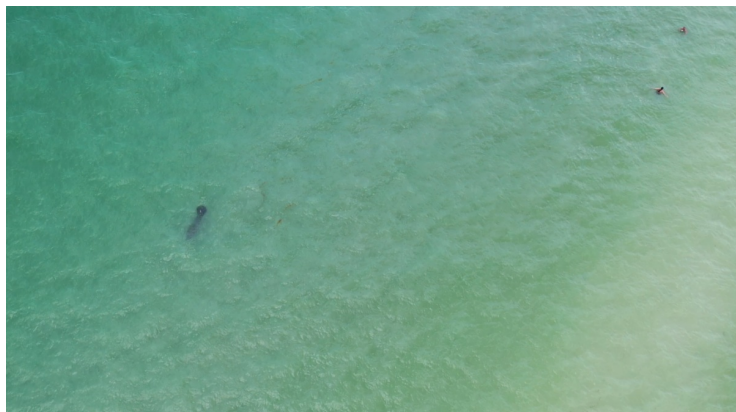
In the previous week (9/1/21 - 9/8/21) water clarity had begun improving due to relatively low precipitation in the watershed and 14-day average flows had been in the optimum range for 12 days. In the picture on the left, taken on 9/9/21 near the lighthouse, a manatee can be seen swimming at the beach. The water was teal and somewhat turbid. Now, increased precipitation has resulted in increased

flows and brown water within a matter of 5 days with flows > 2,100 cfs. In the virtual tour of Lighthouse Beach Park below, you can see that brown water has pushed out beyond the estuary and into the Gulf of Mexico. Water color and flow are correlated: the greater the flow from the watershed (and Lake Okeechobee) the darker the water.

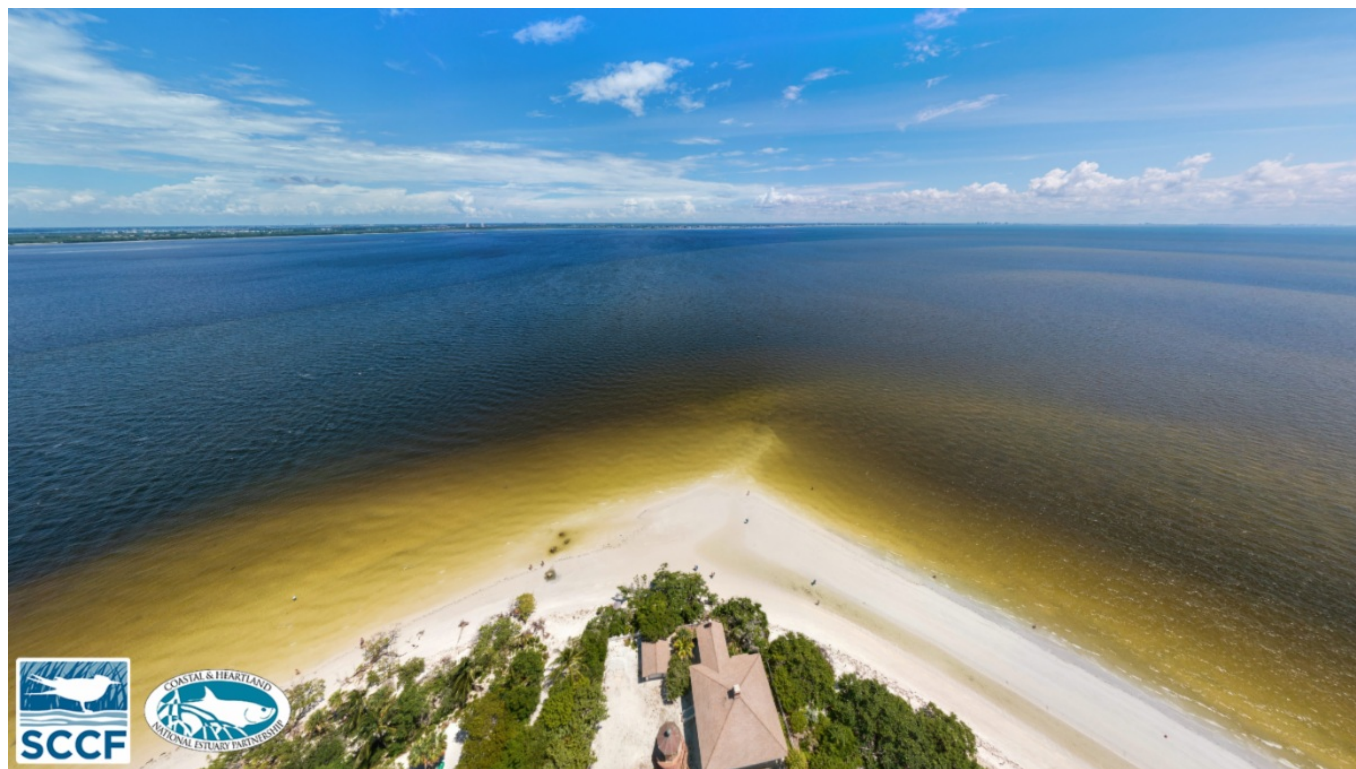
## Virtual Water Quality Tour from Lighthouse Beach

[Click here](#) or on the image above to take a virtual tour from above Lighthouse Beach Park to see how the water looked this week.

With no flows from Lake Okeechobee, water clarity and quality is only being affected by the watershed and stormwater runoff from rain. Tropical Storm Nicholas will bring rainfall to Southwest Florida this week (9/15/21 - 9/18/21) resulting in more stormwater runoff.
