## This Week's Water Conditions Update

October 8, 2021

### Water Conditions Tracker

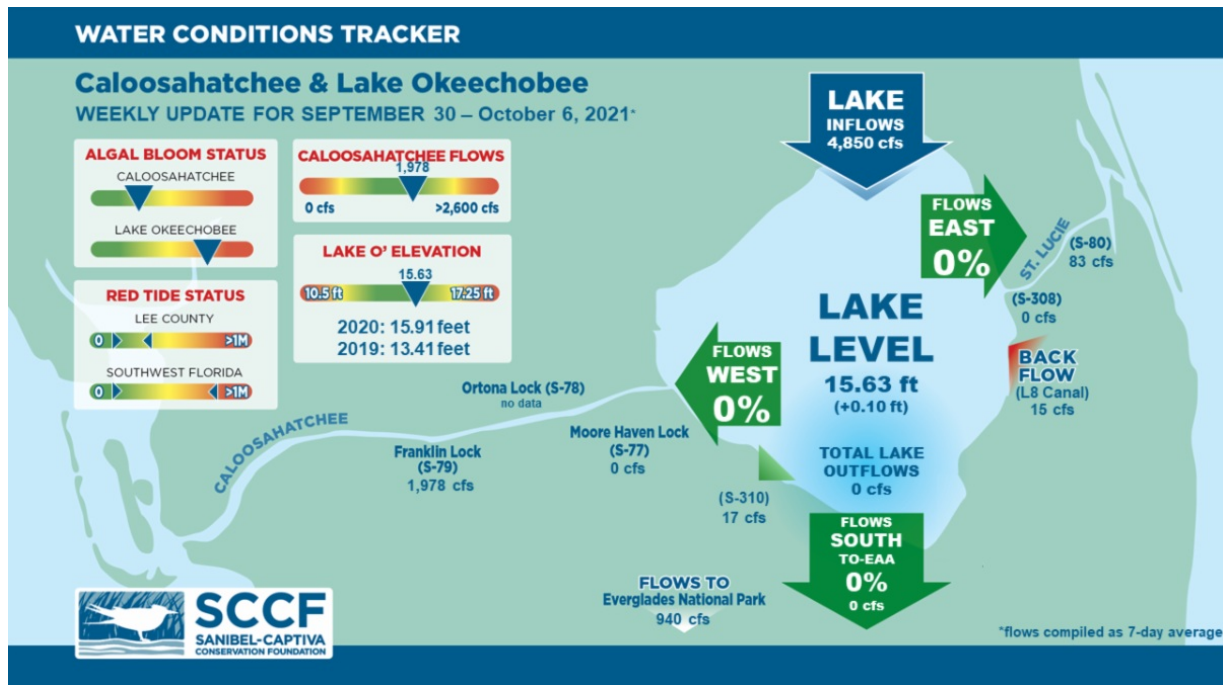
On 10/6/21 Lake Okeechobee was at 15.63 feet (+0.10 feet in the past week). As the dry season weather pattern is developing, the average flow at S-79 decreased to 1,978 cfs (cubic feet per second) this week. The 14-day average flow on 10/6/21 was 4,803 cfs and has been in the **damaging flow envelope** for 20 days. We are still not receiving any flows from Lake Okeechobee. Damaging flows from S-79 for prolonged periods can have negative impacts to seagrass and oysters, which are important indicator species in the Caloosahatchee Estuary.

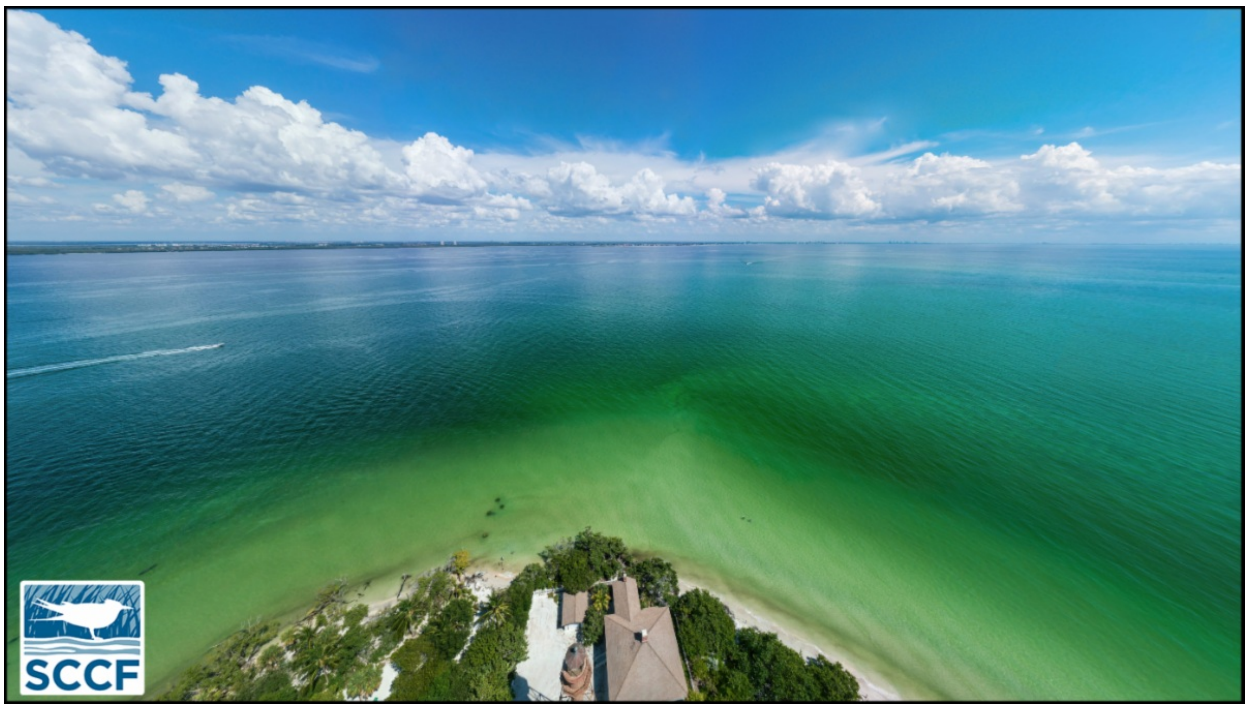
[Click here](#) or on the image above to take a virtual tour from above Lighthouse Beach Park to see how the water looked this week.

With no flows from Lake Okeechobee, water clarity and quality is only being affected by the watershed and stormwater runoff from rain. Decreased rainfall and runoff is resulting in an improvement in water clarity. Photo was taken on 10/5/21 at 2:07 PM on falling tide (high tide @ 12:17 PM (3.1ft)).

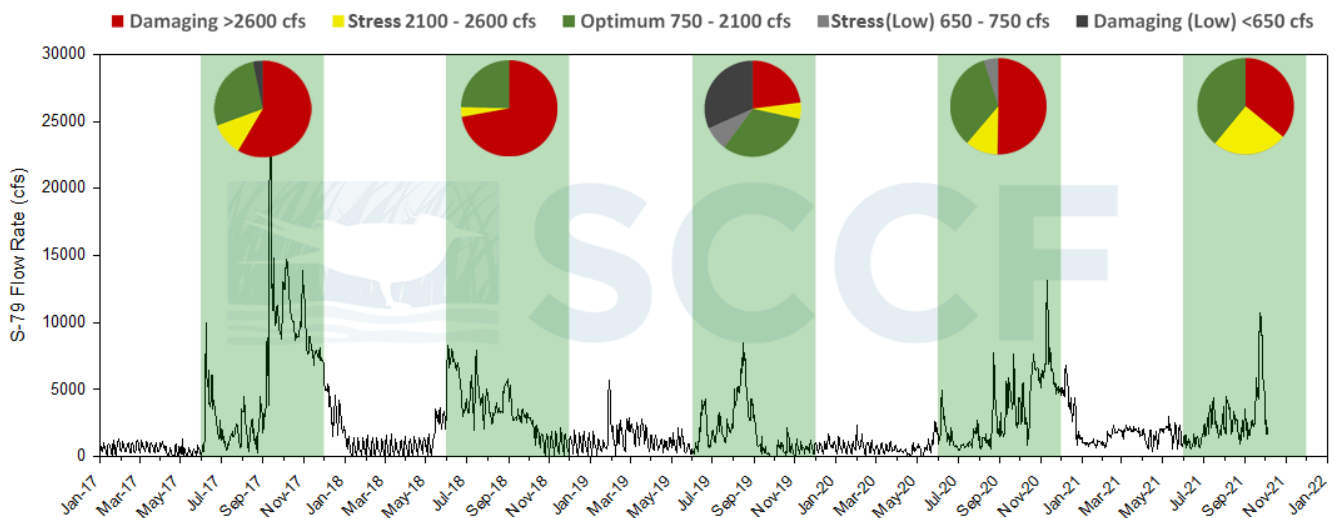
The graph above shows the past 5 years of flow at the W.P. Franklin Lock and Dam (S-79) in Alva. The shaded green areas represent the 6 months of the year that are typically associated with the wet season and are the official Atlantic hurricane season. The pie charts in each section represent the percentage of time spent in the [RECOVER 2020 flow envelopes](#) for the Caloosahatchee Estuary. The optimum flow envelope represents the range of flows that provide salinity regimes that are beneficial to the biology and ecology of the

estuary.

So far this year, the percentage of time spent inside the optimum flow envelope (39%) was greater than the previous four years with 2018 being the least (28%). The 2021 wet season also had the least amount of time spent outside of the optimum flow envelope (61%) compared to the worst year, 2018 at 75%. There are still about 7 weeks left of the hurricane season, but barring any tropical storm or hurricanes, the flow patterns from this years wet season have been marginally better that previous recent years. There is still a lot of room for improvement for water management throughout the Greater Everglades, including sending less water to the Northern estuaries in the wet season, sending more water to the Everglades, creating more water storage throughout the watershed to reduce flows in the wet season and to provide beneficial flows in the dry season, and to optimize the Lake Okeechobee Systems Operation Plan (LOSOM) to reduce the burden on the Caloosahatchee Estuary.
