This Week's Water Conditions Update

October 15, 2021

Water Conditions Tracker

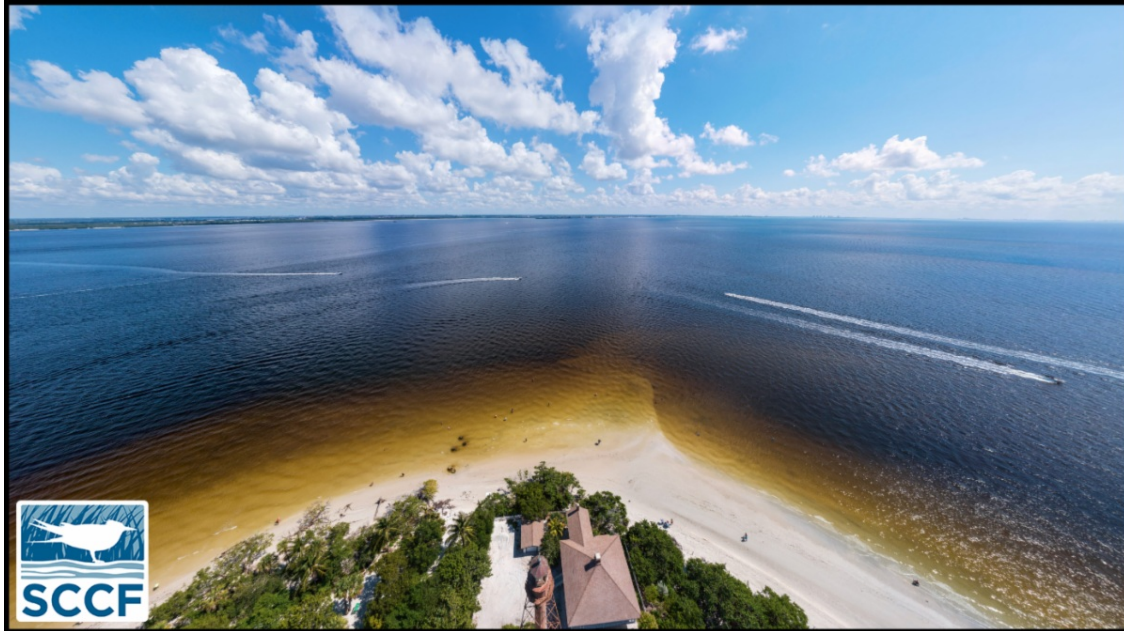
Virtual Water Quality Tour from Lighthouse Beach

[Click here](#) or on the image above to take a virtual tour from above Lighthouse Beach Park to see how the water looked this week.

With no flows from Lake Okeechobee, water clarity and quality is only being affected by the watershed and stormwater runoff from rain. Photo was taken on 10/12/21 at 12:23 PM on low tide (low tide @ 1:25 PM (0.14ft)).
