This Week's Water Conditions Update

October 22, 2021

Water Conditions Tracker

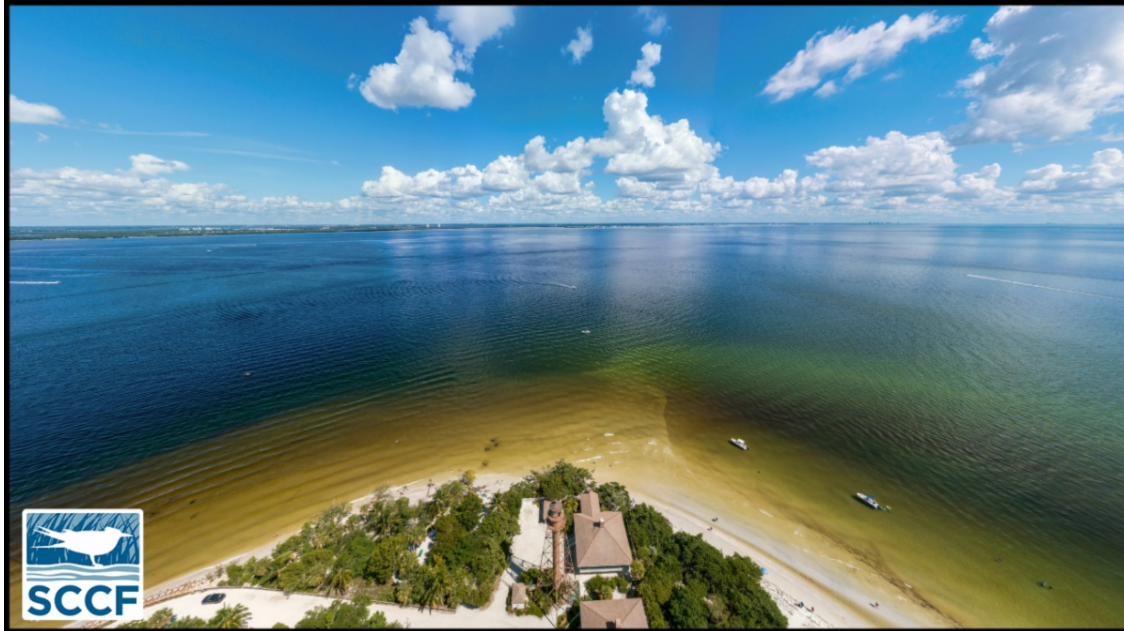
Virtual Water Quality Tour from Lighthouse Beach

[Click here](#) or on the image above to take a virtual tour from above Lighthouse Beach Park to see how the water looked this week.

With no flows from Lake Okeechobee, water clarity and quality is only being affected by the watershed and stormwater runoff from rain. Photo was taken on 10/15/21 at 1:54 PM on low tide (low tide @ 4:55 PM (0.33ft)).
