This Week's Water Conditions Update

November 19, 2021

Water Conditions Tracker

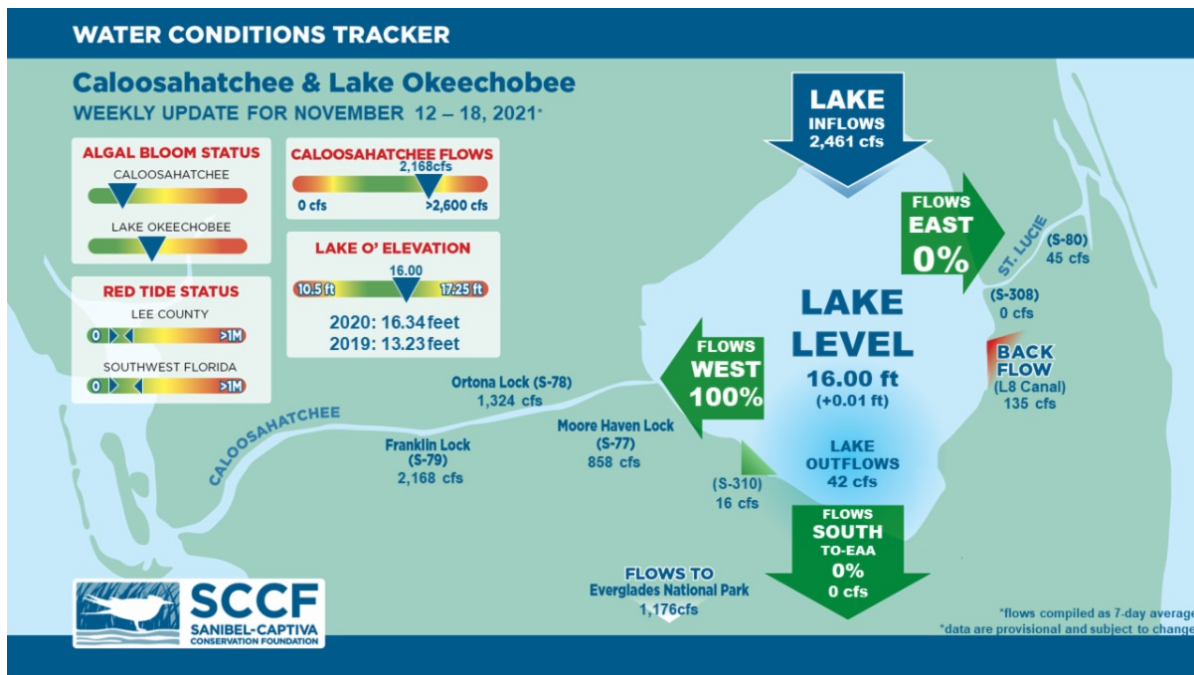
Lake Okeechobee Levels & Caloosahatchee Flow Impacts

On 11/18/21 Lake Okeechobee was at 16.00 feet increasing by 0.01 feet in the past week. The weekly average flow at S-79 was 2,168 cfs (cubic feet per second) this week and flow from the Lake at S-77 was an average of 858 cfs. The 14-day average flow on 11/18/21 was **2,720 cfs** and has been in the **damaging** flow envelope (>2,600 cfs) for 2 days and above the optimal flow envelope for 11 days.
