## This Week's Water Conditions Update

December 17, 2021

### Water Conditions Tracker

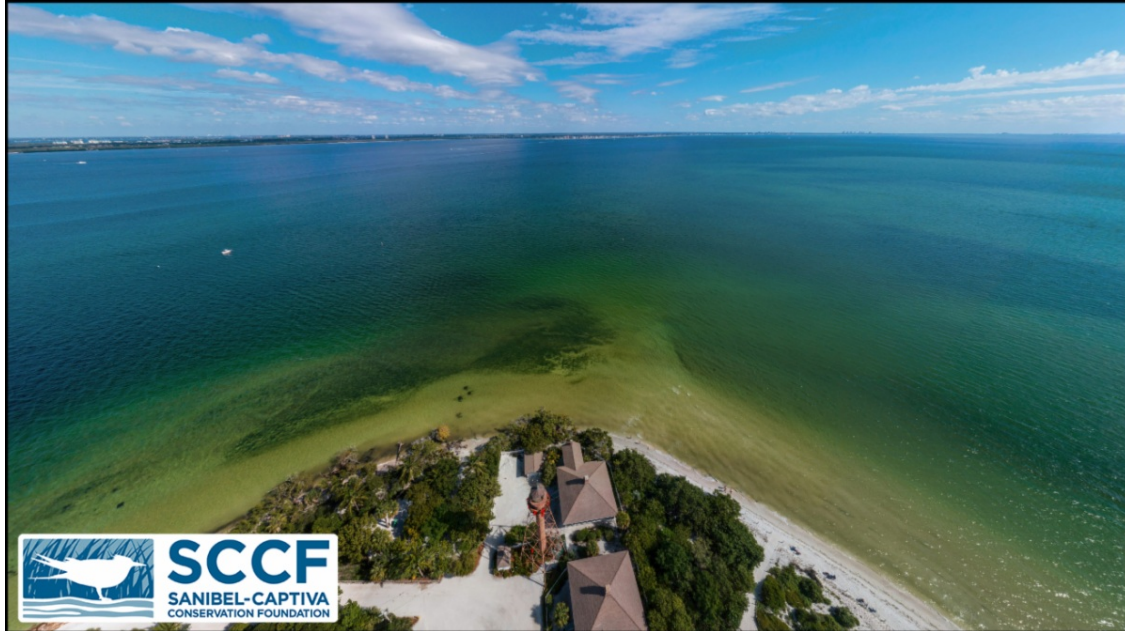
## Virtual Water Quality Tour from Lighthouse Beach

[Click here](#) or on the image above to take a virtual tour from above Lighthouse Beach Park to see how the water looked this week.

Photo was taken on 12/14/21 at 11:07 AM on a falling tide (high tide @ 10:09 AM (1.57ft)).
