This Week's Water Conditions Update

December 24, 2021

Water Conditions Tracker

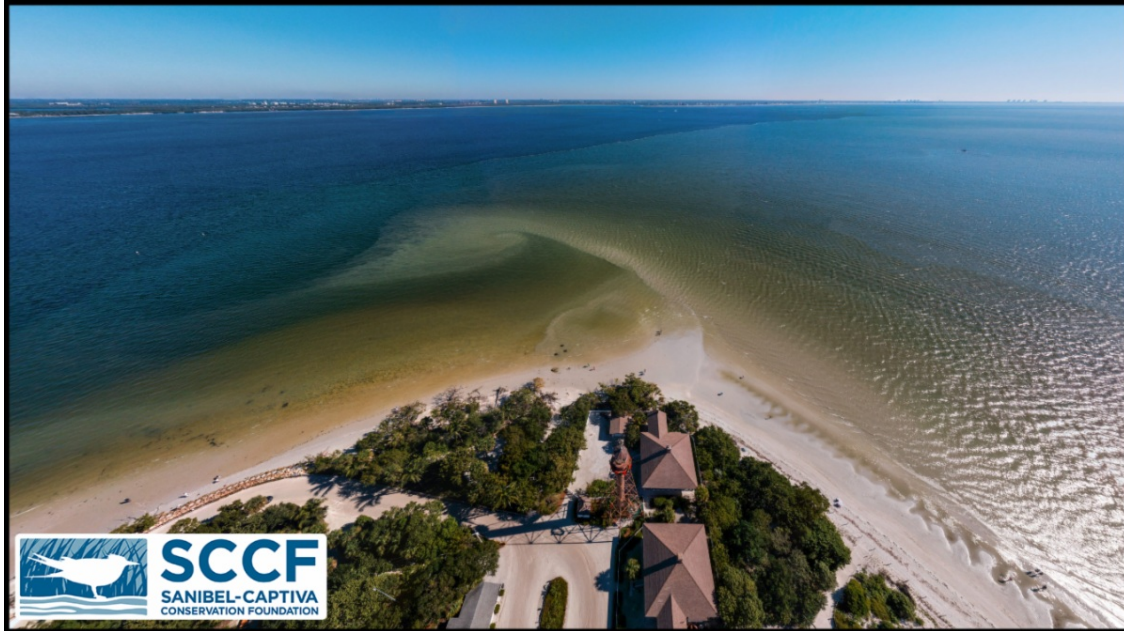
Virtual Water Quality Tour from Lighthouse Beach

[Click here](#) or on the image above to take a virtual tour from above Lighthouse Beach Park to see how the water looked this week.

Photo was taken on 12/23/21 at 10:50 AM on a rising tide (low tide @ 9:54 AM (-0.54ft)).
