This Week's Water Conditions Update

March 18, 2022

Water Conditions Tracker

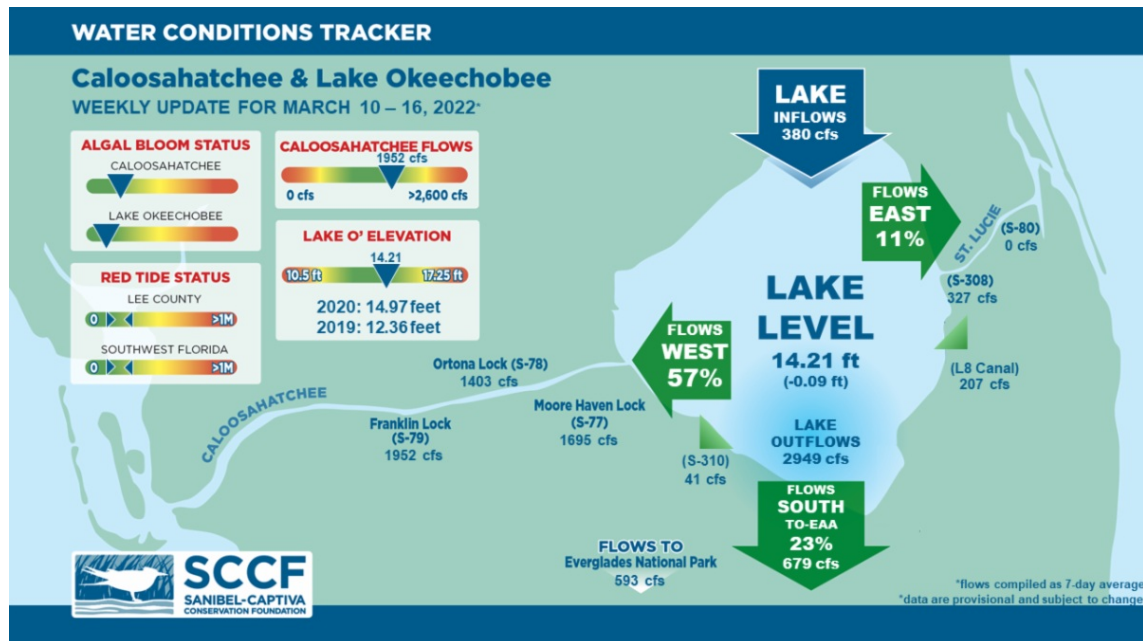
Lake Okeechobee Levels & Caloosahatchee Flow Impacts

On 3/16/22 Lake Okeechobee was at 14.21 feet, decreasing by 0.09 feet in the past week. The weekly average flow at S-79 was 1,952 cfs (cubic feet per second) and flow from the Lake at S-77 was an average of 1,695 cfs. The 14-day average flow was **1,943 cfs** and has been in the **optimal flow envelope for 113 days**.

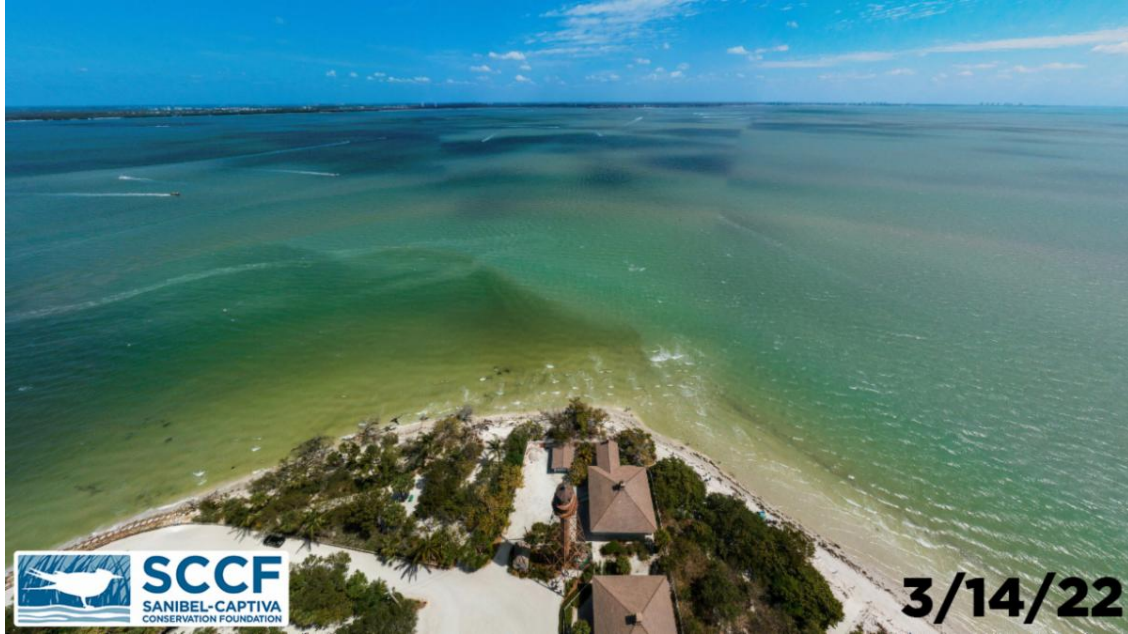
Virtual Water Quality Tour from Lighthouse Beach

[Click here](#) or on the image above to take a virtual tour from above Lighthouse Beach Park to see how the water looked this week.

Photo was taken on 3/14/22 at 1:16 PM on a hide tide (high tide @ 12:58 PM (1.66 ft)).
