This Week's Water Conditions Update

April 22, 2022

Water Conditions Tracker

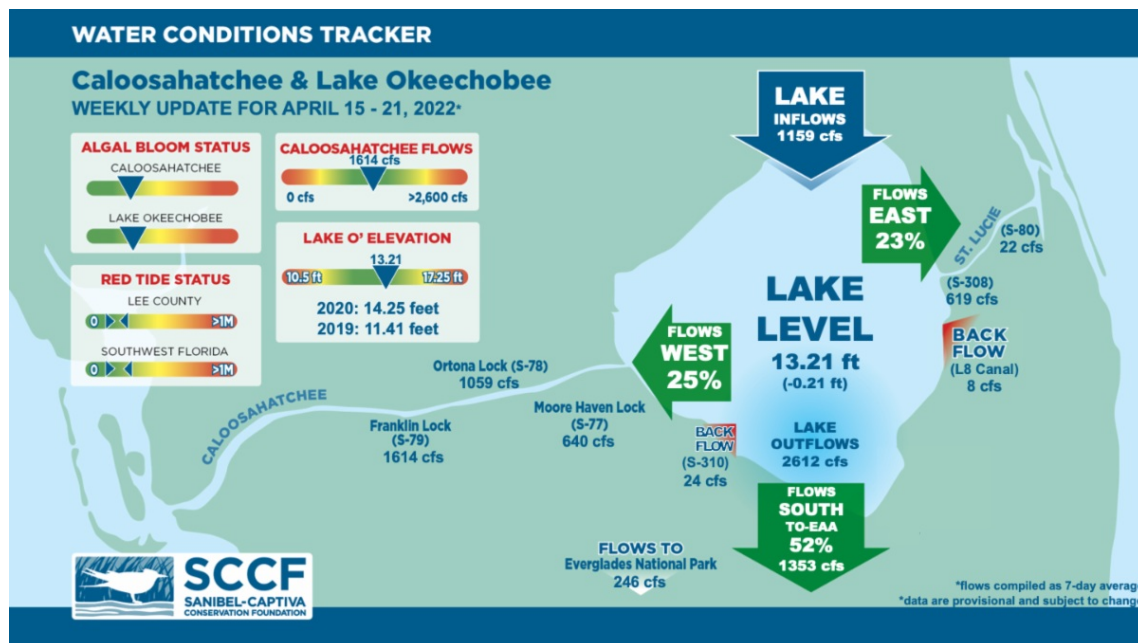
Lake Okeechobee Levels & Caloosahatchee Flow Impacts

On 4/21/22 Lake Okeechobee was at 13.21 feet, decreasing by 0.21 feet in the past week. The weekly average flow at S-79 was 1,614 cfs (cubic feet per second) and flow from the Lake at S-77 was an average of 640 cfs. The 14-day average flow was **1,698 cfs** and has been in the **optimal flow envelope for 149 days**.

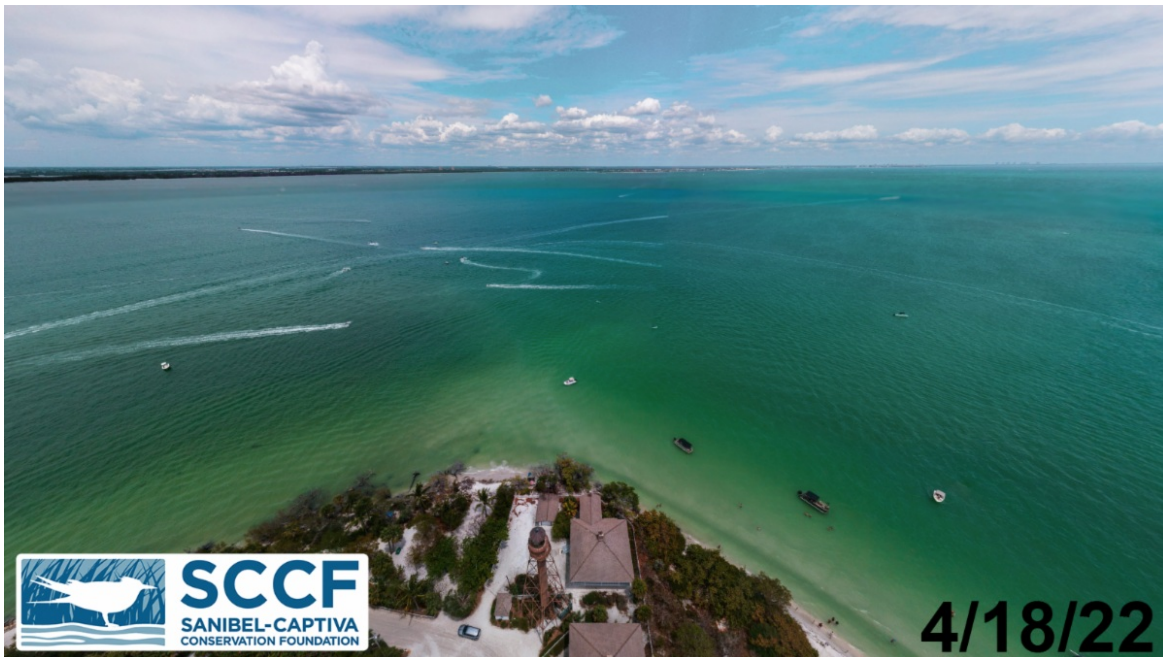
Virtual Water Quality Tour from Lighthouse Beach

[Click here](#) or on the image above to take a virtual tour from above Lighthouse Beach Park to see how the water looked this week.

Photo was taken on 4/18/22 at 1:56 PM on a high tide (high tide @ 1:12 PM (3.08 ft)).
