## This Week's Water Conditions Update

May 13, 2022

### Water Conditions Tracker

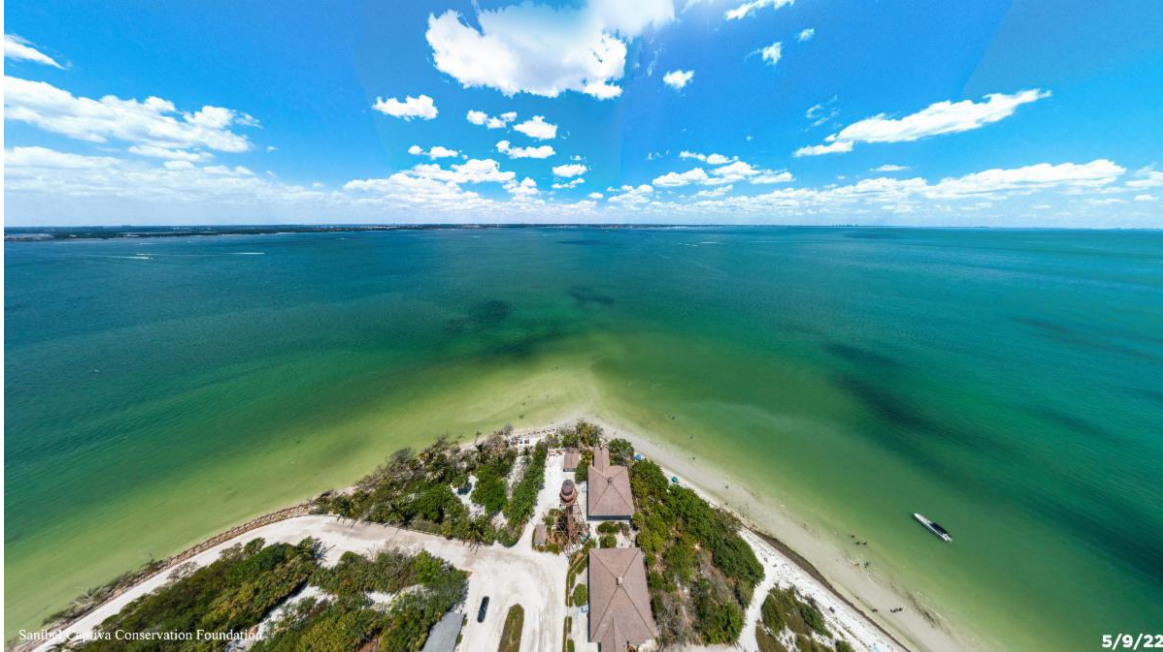
[Click here](#) or on the image above to take a virtual tour from above Lighthouse Beach Park to see how the water looked this week.

Photo was taken on 5/9/22 at 1:49 PM on a low tide (low tide @ 2:07 PM (1.76ft)).
