This Week's Water Conditions Update

May 20, 2022

Lake Okeechobee Levels & Caloosahatchee Flow Impacts

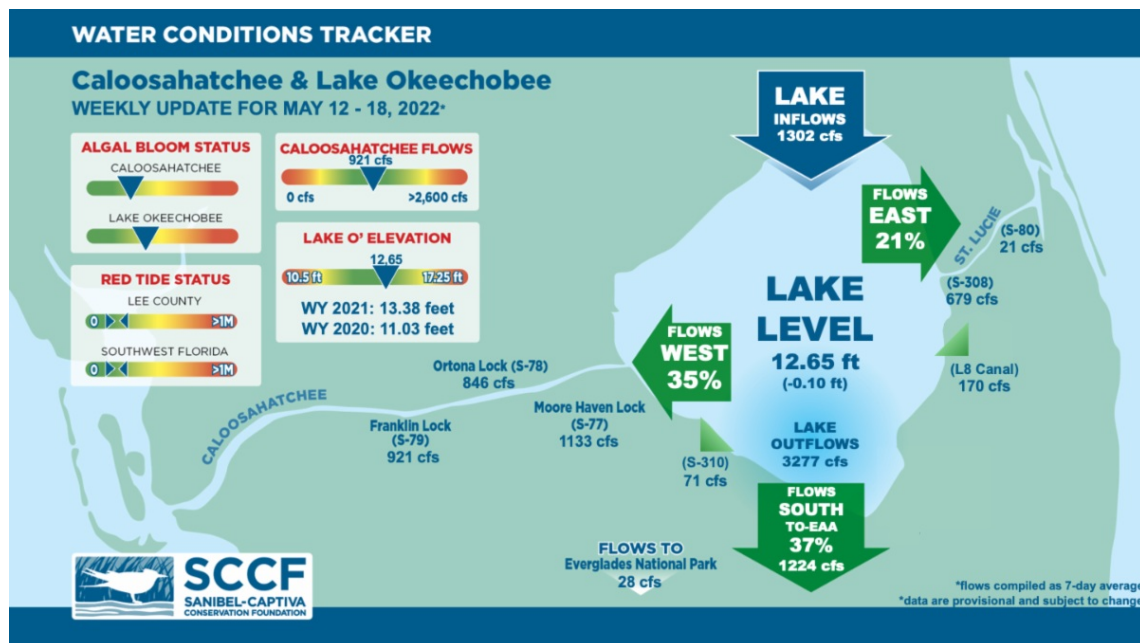
Water Conditions Tracker

On 5/18/22 Lake Okeechobee was at 12.65 feet, decreasing by 0.10 feet in the past week. The weekly average flow at S-79 was 921 cfs (cubic feet per second) and flow from the Lake at S-77 was an average of 1133 cfs. The 14-day average flow was **970 cfs** and has been in the **optimal flow envelope for 176 days**.
