This Week's Water Conditions Update

June 10, 2022

Water Conditions Tracker

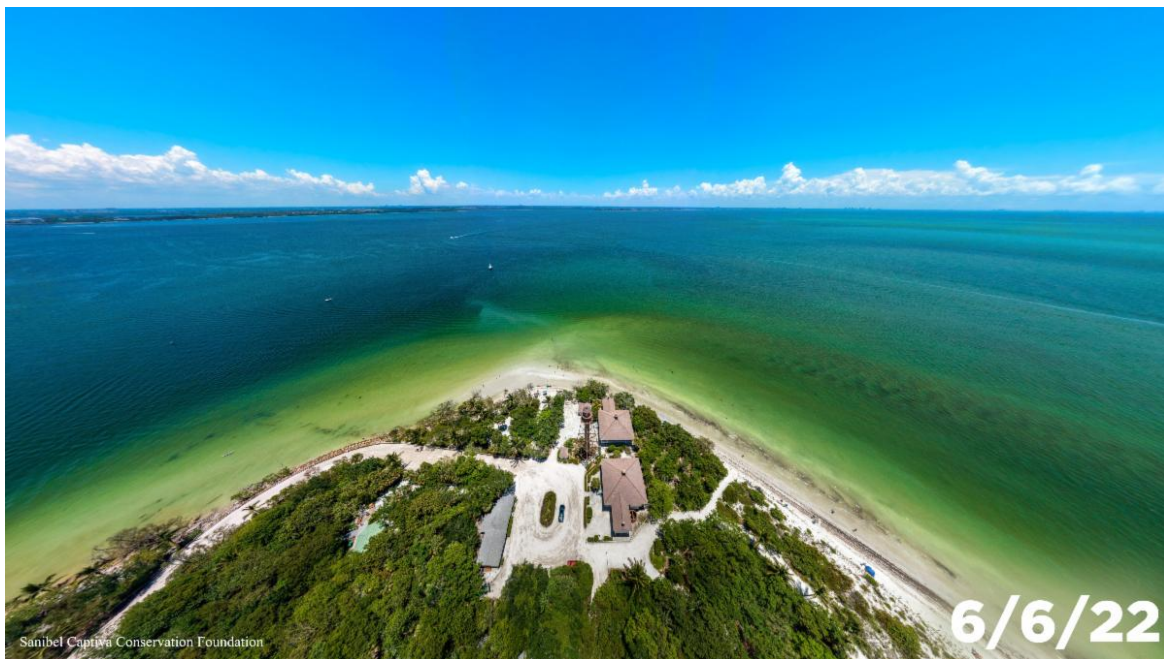
Virtual Water Quality Tour from Lighthouse Beach

[Click here](#) or on the image above to take a virtual tour from above Lighthouse Beach Park to see how the water looked this week.

Photo was taken on 6/6/22 at 2:16 PM on a rising tide (Low tide @ 11:49 AM (1.72ft)).
