This Week's Water Conditions Update

September 23, 2022

Water Conditions Tracker

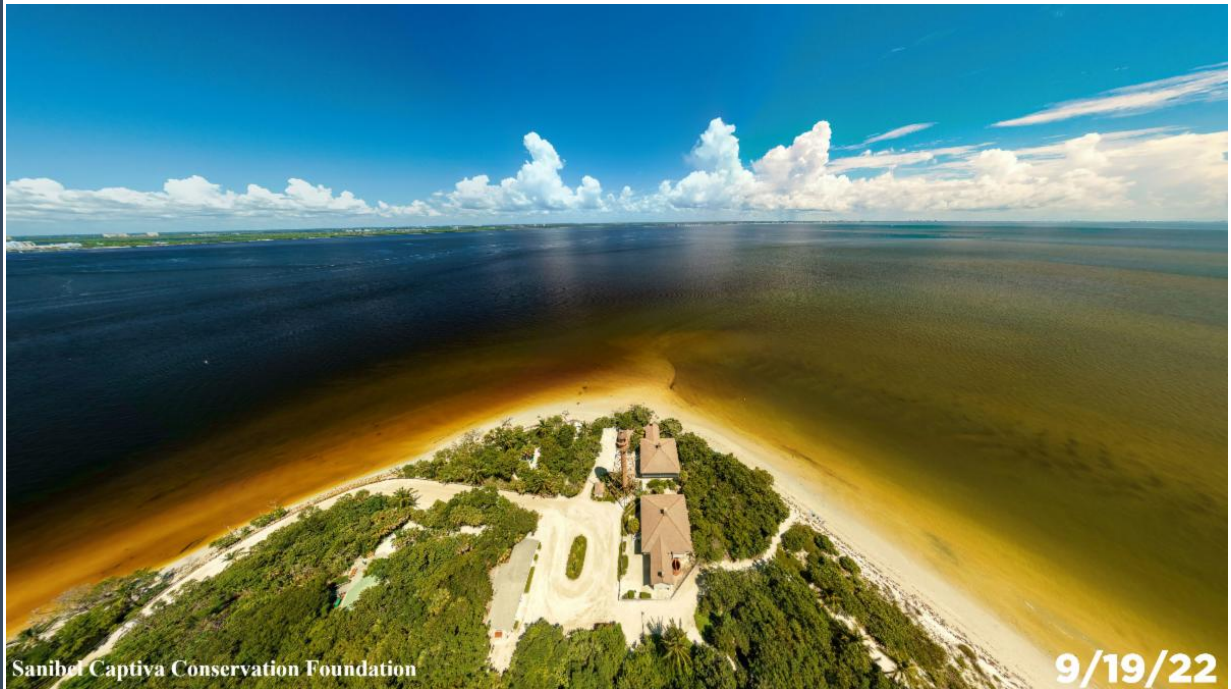
Virtual Water Quality Tour from Lighthouse Beach

[Click here](#) or on the image above to take a virtual tour from above Lighthouse Beach Park to see how the water looked this week.

Photo was taken on 9/19/22 at 1:56 PM on a falling tide (Low tide @ 4:11 PM (0.51 ft)).

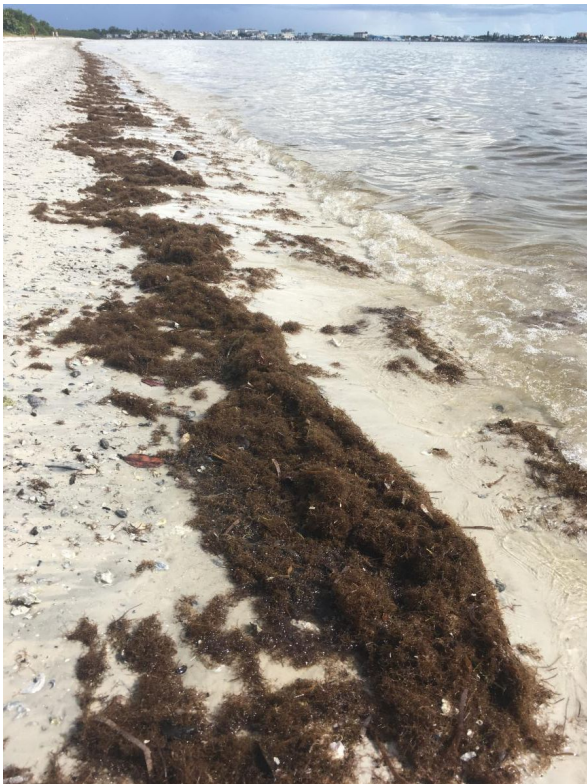
Red algae (*Hypnea*) accumulation on Bunche Beach on 9/17/22. SCCF.
